## AIGC Solutions – Smart and IoT Devices

### *Case Study: Use of LiDAR camera for underground tunnel inspection*

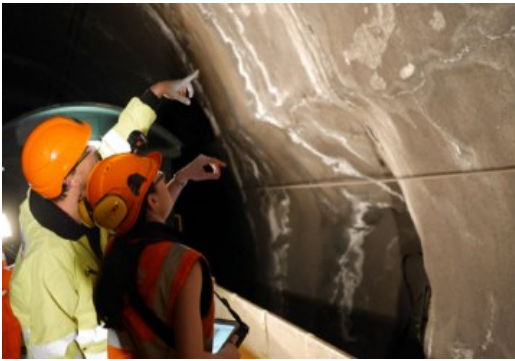
A mobile wheeled-robot is installed with LiDAR system and pre-programmed to autonomously go through the tunnels to

360-degree scan the tunnel walls. In some cases where the wall is too high for the robot, a caged-drone is installed to fly inside and scan close to the walls to gather detailed accurate 3D points of the structure. The data is then generated to present a very detailed 3D images of the wall structure. Any cracks can easily be detected.
